MAGNETIC RESONANCE LYMPHOGRAPHY DEMONSTRATES SPONTANEOUS LYMPHATIC DISRUPTION AND REGENERATION IN OBSTRUCTIVE LYMPHEDEMA

N.-F. Liu, Z.-X. Yan, X.-F. Wu, Y. Luo

Lymphology Center of Department of Plastic & Reconstructive Surgery, Shanghai 9th People's Hospital, Shanghai Jiao Tong University School of Medicine, Shanghai, China

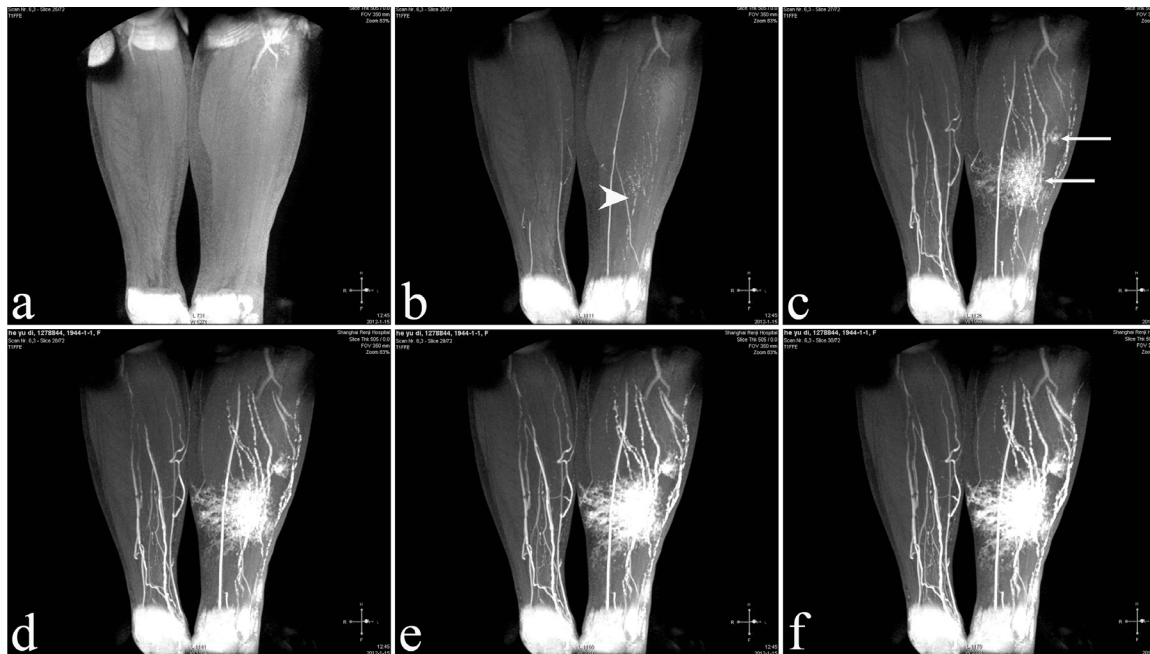
Fig. 2. Dynamic imaging MR lymphangiogram shows lymphatic disruption and lymph leakage in the left lower leg. a. No lymph vessels were visualized on initial inspection. b. Lightly enhanced collecting vessels (arrow head) were observed in the distal part of the lower leg at 8 min. c-f. Anterior tibial lymphatic disruptions and lymph leakage (arrows) were displayed and extravasation of contrast and the enhancement of lymph vessels became evident over time (last image was at 18 min.).

single break in a vessel was usually seen in the middle of its course along the lower leg and the leaking contrast material radiated from the break in the significantly dilated collector with extent increasing with time on dynamic MRL images (*Fig. 2*). In a woman with bilateral lymphedema, lymphorrhoea was observed on images of her lower legs 6 months after surgical treatment of endometrial carcinoma. Lymphorrhoea had completely disappeared in both legs and a mass of proliferated new vessels appeared 1 year later (*Fig. 3a-c*). These results suggest that the anterior tibial lymph vessel is the weak point of the lymph pathway in the lower extremities, and the imaging features of the vessels, such as disruption, lymphorrhoea, and regeneration, reflect the evolution of both lymphatic damage and repair in obstructive lymphedema.

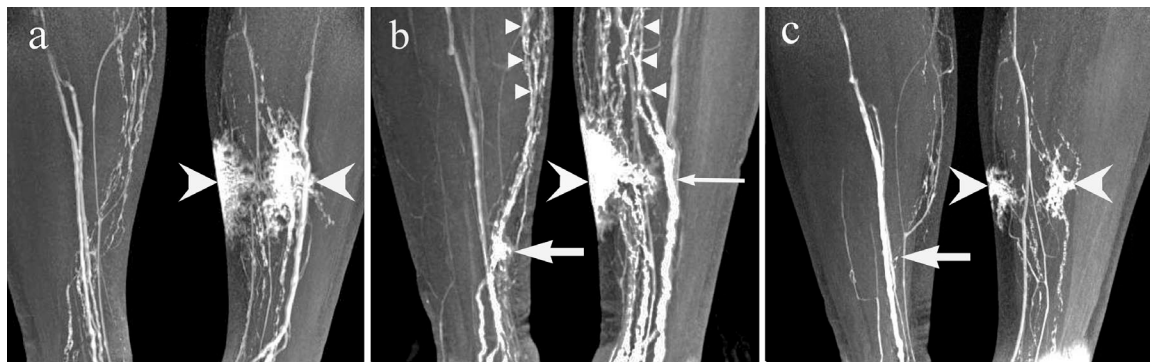
Fig. 3. MR lymphangiogram shows the evolution of lymphatic damage in a patient with bilateral lymphedema. *a.* Anterior tibial lymph collector disruption and lymph leakage (arrowheads) displayed in the left lower leg six months after the first appearance of lymphedema. *b.* One point of lymph leakage was significantly reduced (small arrow) leaving another (arrowhead) in the left leg one month after compression therapy while a new lymphatic disruption was seen in the right lower leg (large arrow). *c.* Lymphorrhea completely disappeared in the right leg (arrow) and a collection of regenerated new vessels appeared between the former ruptured lymphatic collectors in the left leg one year later (arrowheads).
